Case Study: Pickle Basket Repair

Product Description – Repair of PVC Coated Stainless Steel Pickle Baskets

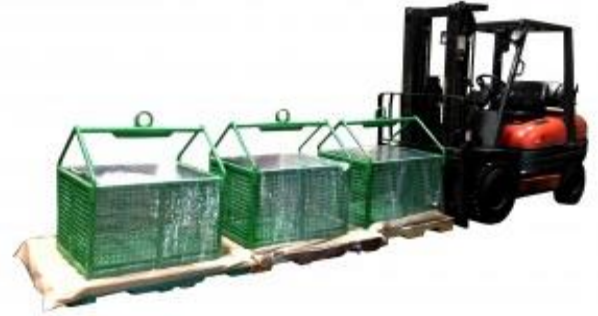
In addition to fabricating new equipment, we support our customers by repairing items for which rework can extend economic life. In this case, our baskets are used in a pickle line to process heavy forgings. Over time the PVC coating is abraded and the side mesh deteriorates. By stripping the coating, replacing mesh, repairing framework as needed and re-coating, the service life can be doubled with approximately 40 – 50% of new cost invested.
